REMEDIAL ACTION STEP OF SUBSYNCHRONOUS VIBRATION TRIP ON STEAM TURBINE

A CASE STUDY OF EGAT SOUTH BANGKOK POWER PLANT

18th Conference of the Electric Power Supply Industry (CEPSI)

By Parichart Suttiprasit

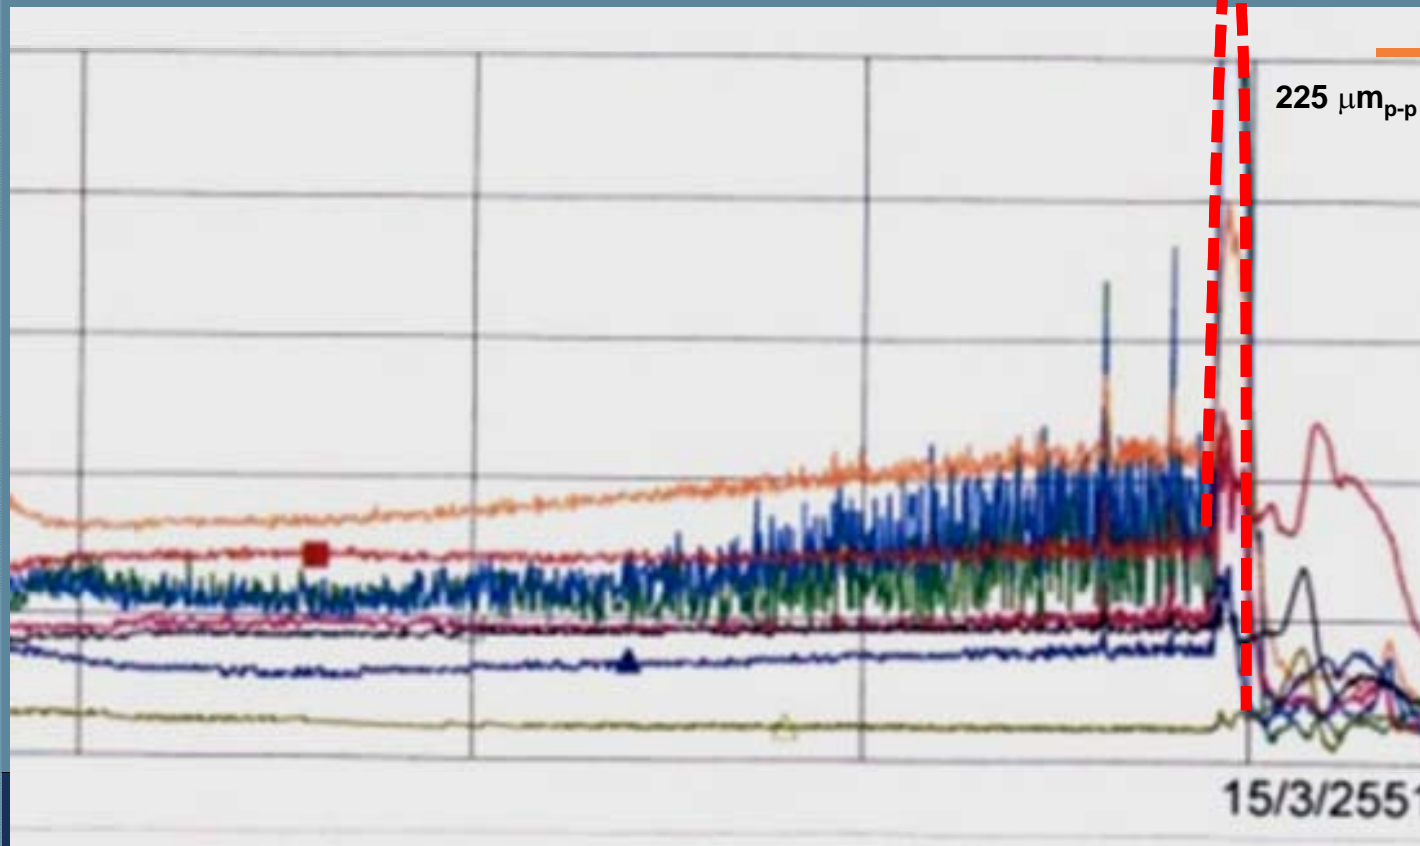
Event Overview

March 15th, 2008

Trip Setting $225 \mu\text{m}_{\text{p-p}}$

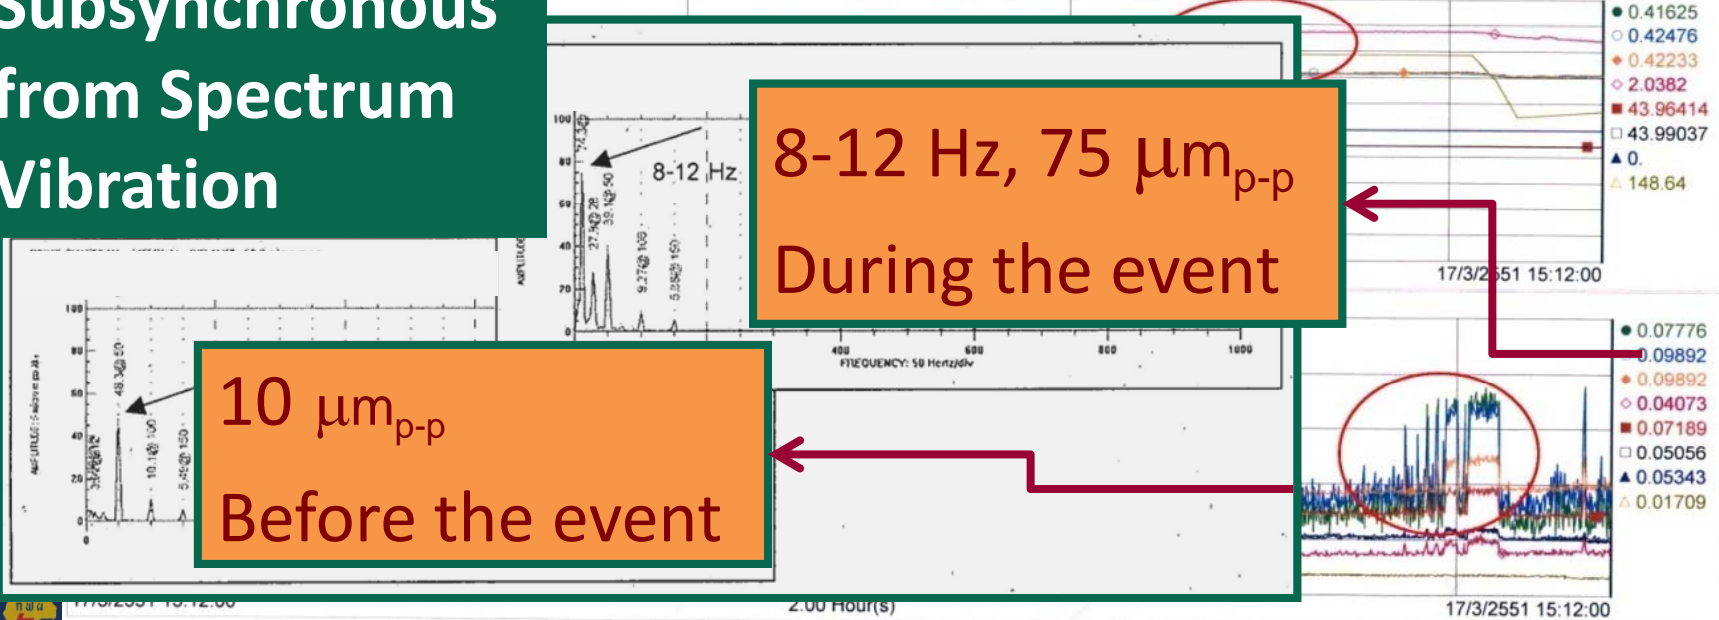
**Subsynchronous
from Spectrum
Vibration**

**8-12 Hz, 75 $\mu\text{m}_{\text{p-p}}$
During the event**

**10 $\mu\text{m}_{\text{p-p}}$
Before the event**

3 options to correct

**“Fluid Induced Instability”
without Internal Inspection**

- ① **6-day Compromised Balancing**
- ② **8-day Bearing Inspection**
- ③ **Lube Oil Temperature Adjusting**

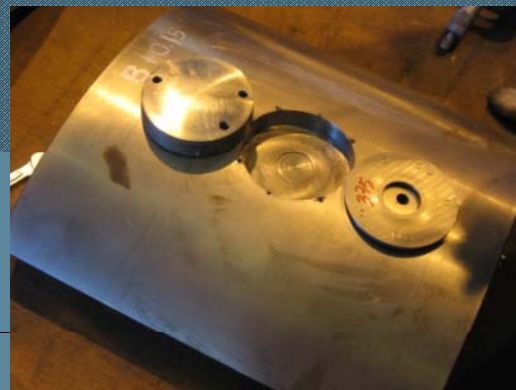
Bearing
Replacing

“Higher Load
Supply
Run Longer”

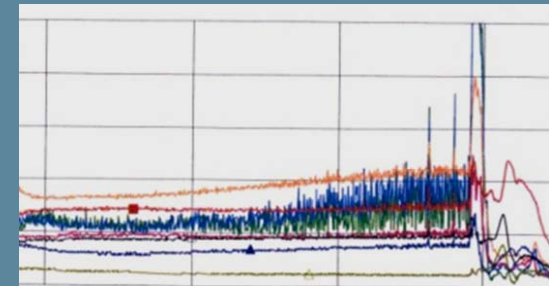
Although “Higher Load Supply
Run Longer”, it could not be reduced Vibration
without Internal Part Correction anymore!!!

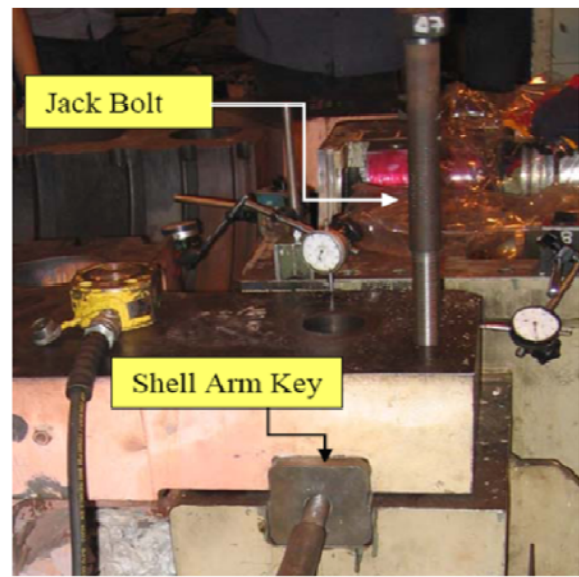
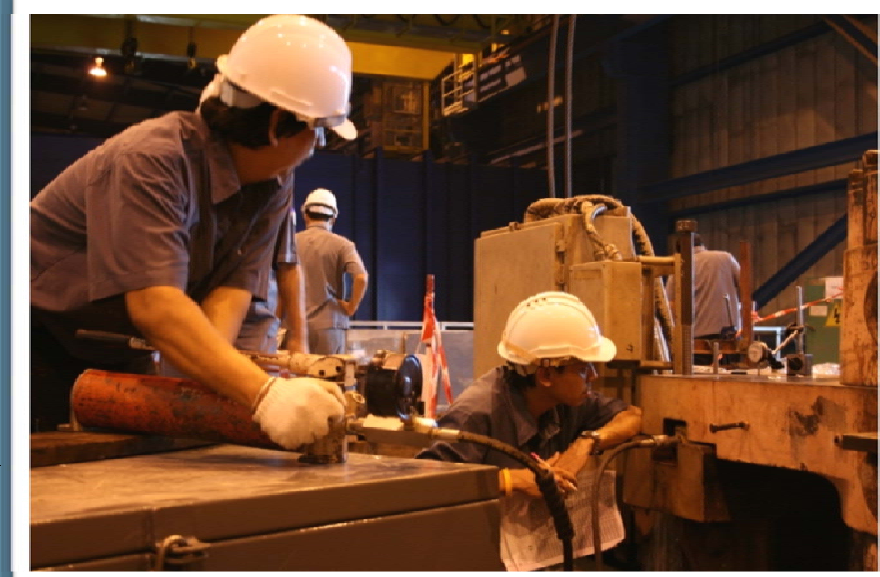
Front Casing Weight Balancing

69%

10%

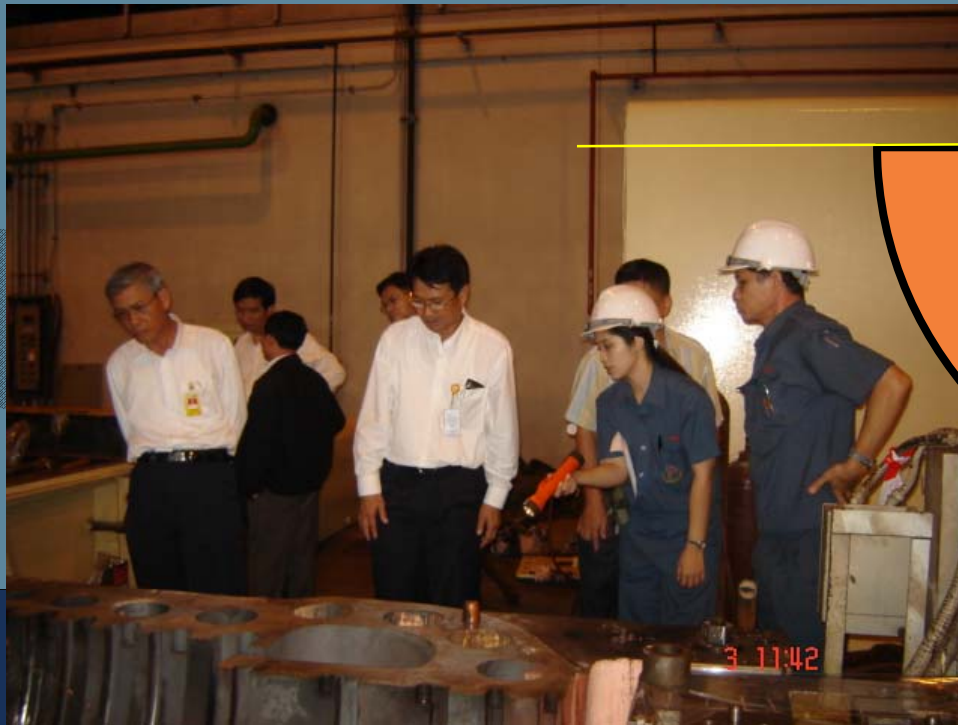
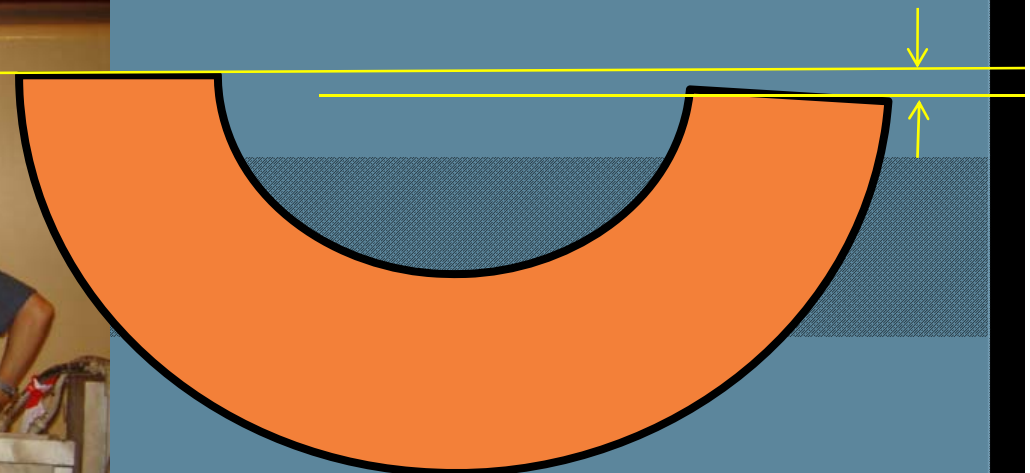
Foundation Level

Right Side of LP Casing Level
Lower than Left Side 2.7 mils

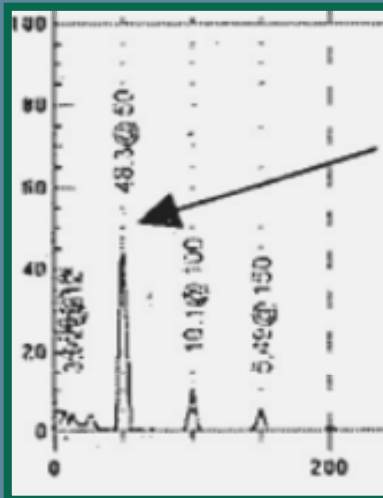
Before

Subsynchronous of $10 \mu\text{m}_{\text{p-p}}$

Trip at $1X=230 \mu\text{m}_{\text{p-p}}$

@60 MW (52% Load)

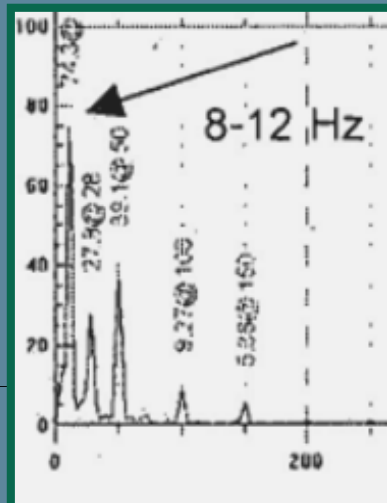
After

Subsynchronous of $80 \mu\text{m}_{\text{p-p}}$

@100 MW (87% Load)

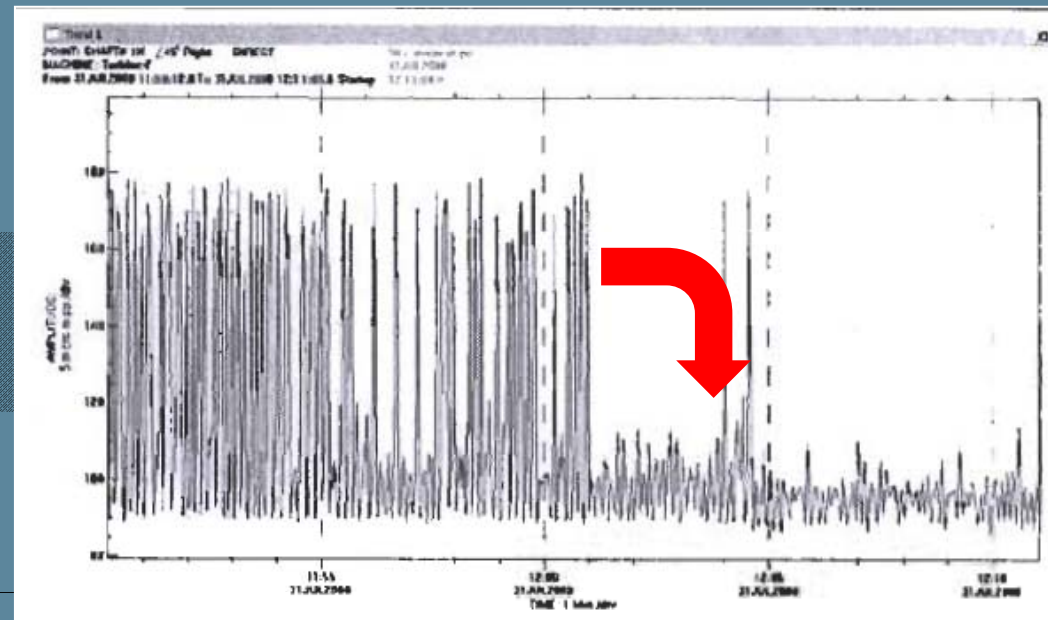
More Stable ; however, Need more Fine Tuning
By Lube Oil Temp. Decreasing from 49°C to 45 °C

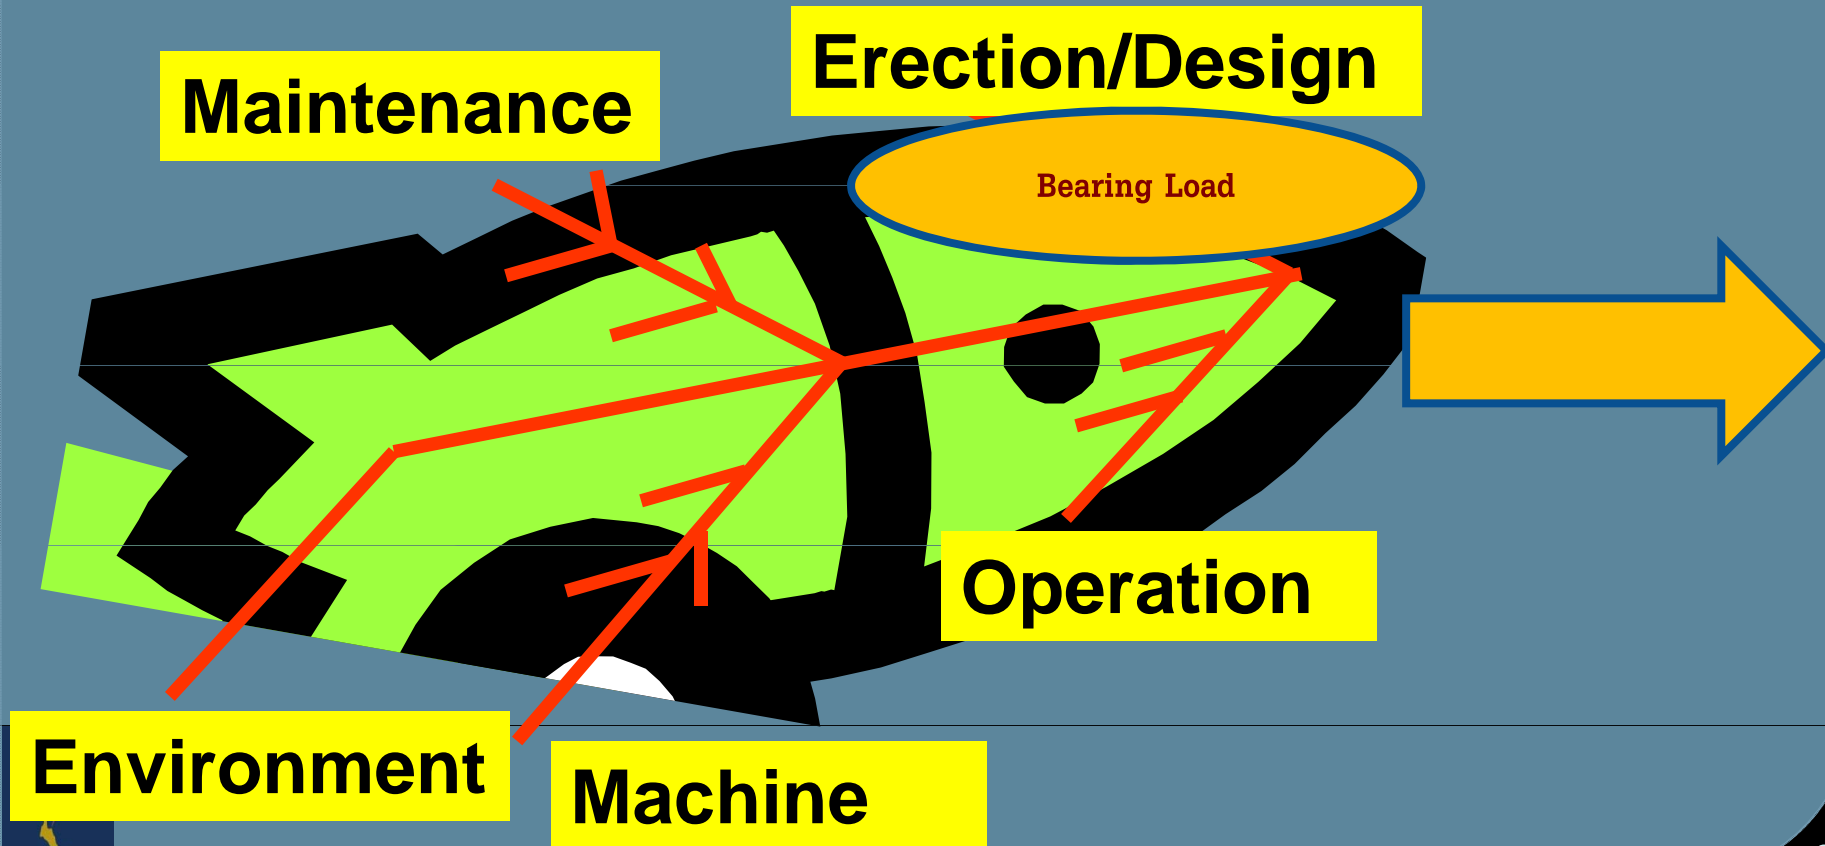
“Last possible cause in the fish bone diagram was found and corrected.”
