Stress Corrosion Cracking on Steam Turbine Rotor Grooves: Experiences and Countermeasures from EGAT Power Plants

**Kobchai Wasuthalainan, Kanit Nangkala,
and Santhiti Chantha-Uthai
Electricity Generating Authority of
Thailand (EGAT), Thailand**

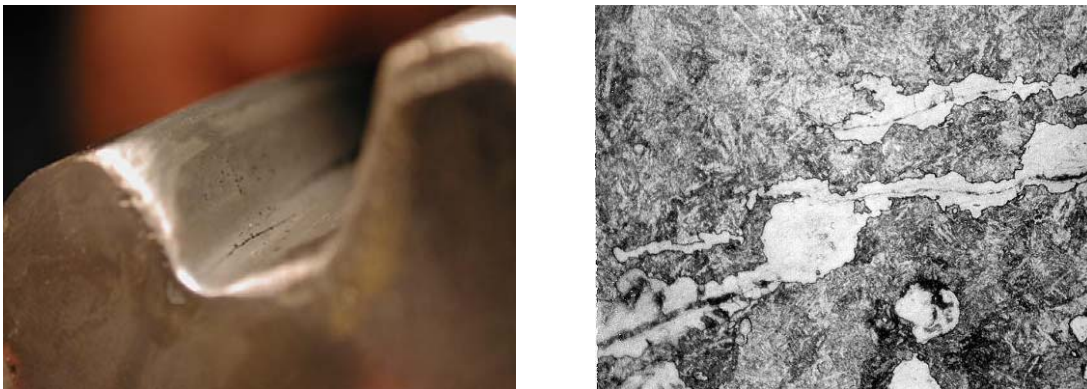
Figure 1 Example of Stress Corrosion Cracking on LP rotor groove

(left) crack and pitting corrosion at LP rotor groove

(right) microstructure of crack examined by replication

some heat treatment processes, it can be seen from figure 1 that SCC exhibits multi-branched inter-granular crack pattern in martensitic steel.

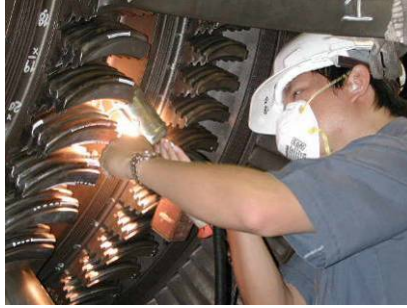
Figure 2 Replication test after several indications on rotor grooves were found

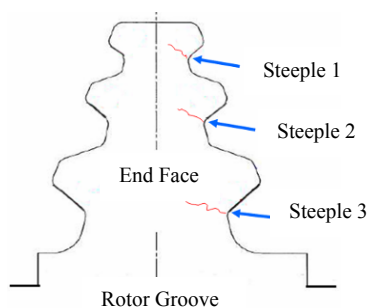
Figure 3 Schematic of axial-entry fir tree groove design in LP rotor with typical cracking locations shown

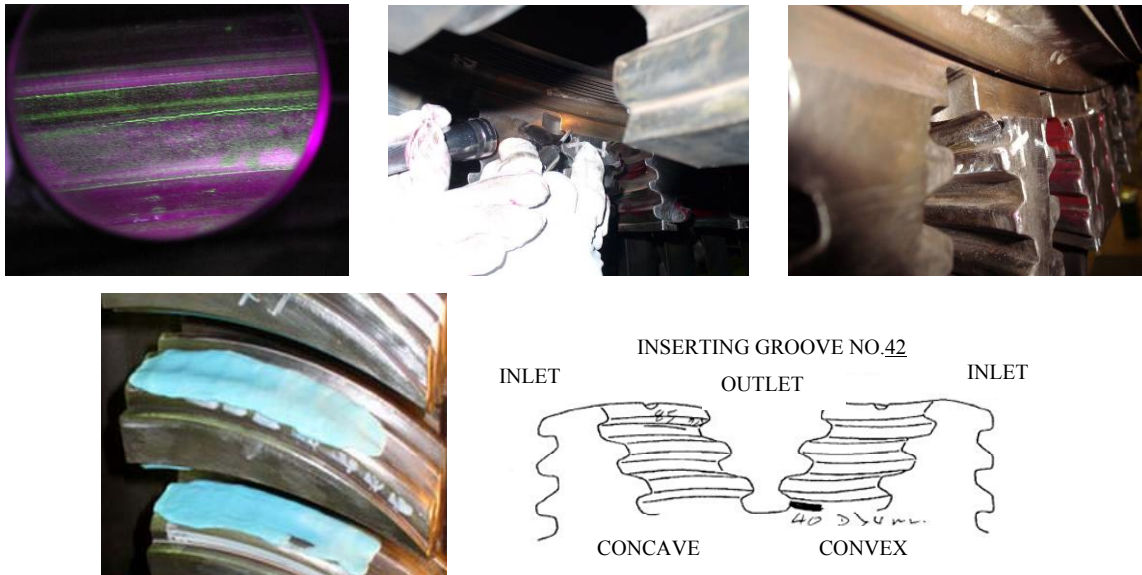
Figure 4 Steps of crack grinding

(Left) Crack found on LP rotor grooves

(Middle) Grinding-off crack found on LP rotor groove with small milling

(Right) 0.5 mm depth of ground-off crack

(Bottom-Left) Silicone replication of ground crack for measuring final depth & length

(Bottom-Right) Inspection sheet recorded all ground cracks found

One common countermeasure to cracks found on EGAT’s LP rotor grooves is grinding technique. After NDT confirmed cracks discovered, grinding with small grinding machine (Figure 4) would be performed by skilled technicians. The first grinding will be limited to about 0.1 mm deep before another NDT to check for crack

remaining. If cracks still exist, another 0.1 deep grinding and NDT will be repeated until there is no crack remained. The final depth and length of all ground cracks are measured by using silicone replication, and recorded along with cracks' location in the inspection sheet for further consideration. The whole process of crack grinding normally takes about 2 days per turbine stage. However the duration may vary depending on numbers and depth of cracks discovered.

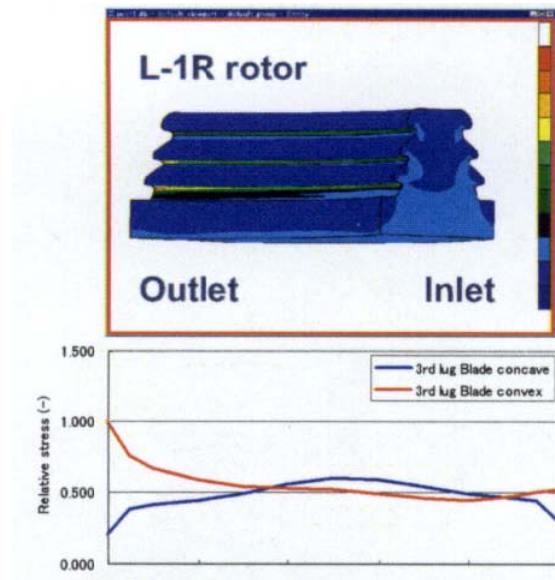
2001. The result shows that this groove type has relatively high local stress at the inlet and outlet (see figure 5).

Figure 5 Relative stress distributions on L-1 groove (BPK-T1, 2)

The FEA coincides with actual inspection results both BPK-T1 and 2 performed during 2003 and 2001 respectively. Firstly, remaining life of 2 LP rotors of BPK-T2 were estimated at around 18,500 hours. Because maximum crack depth will occur at the end face of rotor groove so we can reexamine the crack depth and crack growth rate without removing L-1 blades off. The rotor end face inspection (magnetic particle test) can be done every ½ to 2 years by removing cross over pipes and opening upper LP half casings without lifting up the rotors. Outage schedule can be accomplished within 25 days. So running until next Minor Inspection (MI) was preferred to Bangpakong power plant's steam turbines. Finally at the end, these failed rotors were replaced and upgraded by retrofitting LP turbines in year 2005 and 2006 respectively.

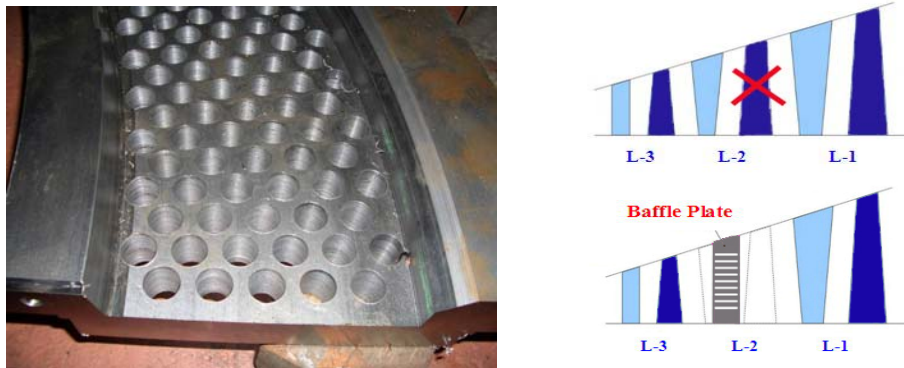
In 2004, South Bangkok thermal plant unit 4 (SB-T4) encountered SCC problem at L-2 stage (gen-side) grooves. After grinding, 6 of 198 grooves had final depth exceeding maximum depth allowed. New rotor replacement was not appropriated due to shutdown time constraint. In order to resume the plant back in service, full-row of moving and stationary blades were removed both side from double flow LP turbine and replaced with baffle plates in order to maintain the same pressure drop inside and minimize effect to nearby stages. After complete installation, operation resumed with limited load of 90%. Estimated time frame for blade removal and baffle plate installation is 2 weeks excluding delivery period of baffle plates.

Figure 6 Illustration of baffle plate and installation in place of stationary blade of LP inner casing at SB-T4

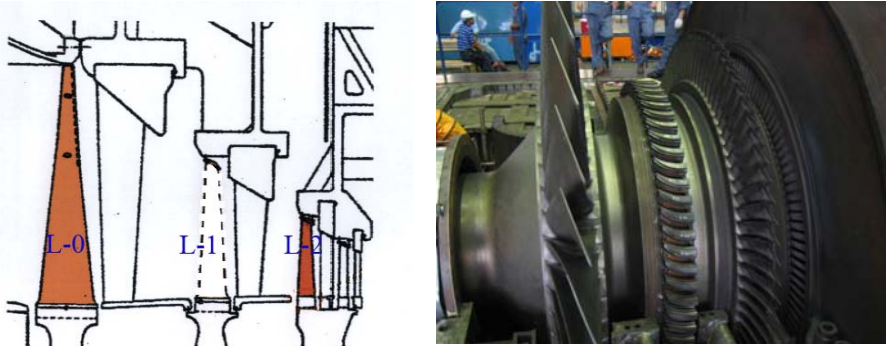
In 2006, Maemoh thermal plant unit 9 (MM-T9) encountered SCC on L-1 grooves. After grinding, numbers of grooves had ground crack depth over 10 mm, which exceeded allowable depth. Unfortunately, blade removal and baffle plates installation were not suitable to this case, because of the downtime constraint. To resume the plant in service as soon as possible, EGAT had considered the moving blades removal with

Figure 7 Illustrated the full-row blade removal of L-1 stage without installation of baffle plate

stationary blades remained. Although this action could cause changes in pressure drop across LP stages, especially to the adjacent stages of L-0 and L-2, limiting operation to 75% load was chosen to mitigate this effect. The unit was operated for 5 months with normal conditions before the new LP rotor arrived for replacement. Estimated time frame for L-1 blade removal from both sides of LP turbine is 2 days.

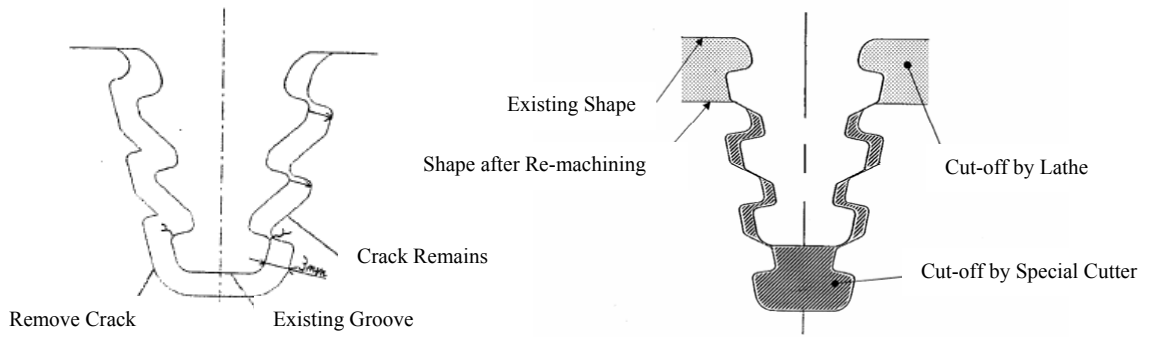
Figure 8 example of LP rotor groove modification

(left) groove machining with enlarge radii

(right) steeple drop machining

Re-machining groove by precise lathe machine with special cutting tools is the one of mechanical repairs. It can be classified into 2 subcategories which are skin cutting or dropped steeple machining. Skin cutting will work only for shallow crack. This method is usually followed by surface polishing and shot-peening to generate residual compressive stress.^[3] Dropped steeple machining on the other hand is the machining to the new pitch circle downward to the centerline of turbine rotor. Both have the same disadvantages that are moderately high cost and unfavorable extended outage. Figure 8 illustrates the idea of dropped notch steeple or undercutting machining. However, groove machining with enlarge radii or steeple drop machining may be inappropriate in some cases, BPK-T1 and 2 for example, 3rd steeple crack still exists in groove as shown in figure 8 (left). Limitation of re-machining is the geometry of groove itself.

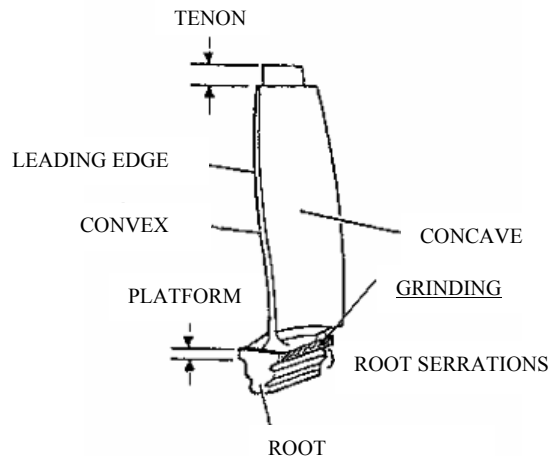
Figure 9 L-0 rotating blade platform grinding

South Bangkok thermal power plant unit 3 to 5 had been tired dropped steeple machining in year 2001, 2001, and 2002 respectively. The rotors were shipped to OEM factory for machining. Some modification works on L-0 rotating blades, flow guides, and gland cones were required since the dimension of rotor groove had been changed. For L-0 rotating blades, blades had been removed and the platforms were machined a little bit thinner than original shape as shown in figure 9. Lining plates have been attached into flow guides and gland cones have been grinded as shown in figure 10. Estimated time frame for corrective is around 9 months including transportation.

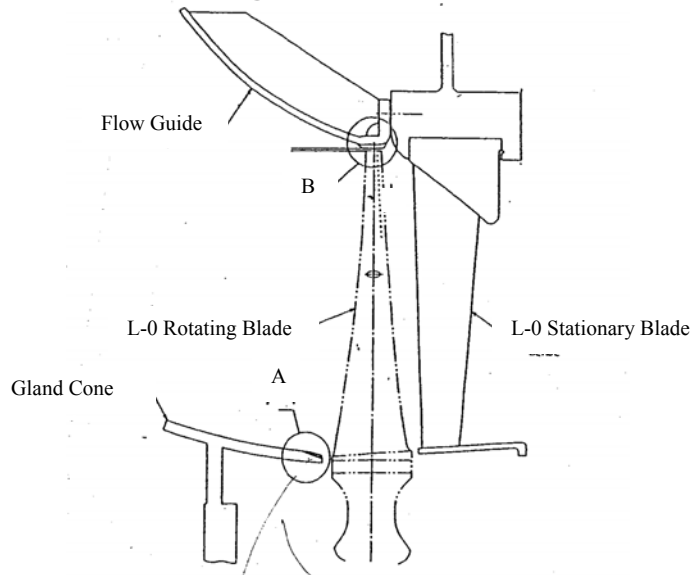
Figure 10 Flow guide and gland cone modification (detail A and B)

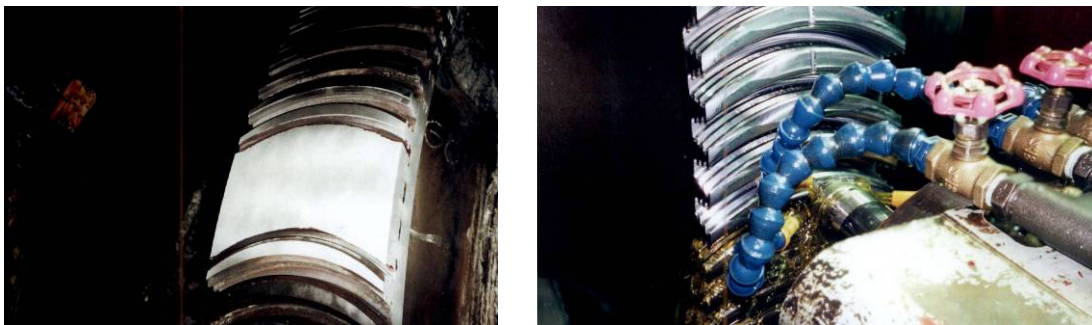
EGAT has one LP rotor welding repair case which is South Bangkok thermal power plant unit 5. Since only dropped steeple machining could not get rid of some cracks on 3rd steeple of rotor then partial welding repair had been employed in additional. Figure 12 shows photographs of L-0 grooves during building up and machining processes. Note that repair job was done at OEM workshop in 2002.

Figure 12 building up metal and re-machining on L-0 grooves (SB-T5)

(left) Penetrant test on build up metal after finished welding repair

(right) L-0 re-machining
