REMEDIAL ACTION STEP OF SUBSYNCHRONOUS VIBRATION TRIP ON STEAM TURBINE: A CASE STUDY OF EGAT SOUTH BANGKOK POWER PLANT

The 115 MW - single cylinder, single flow type - Steam Turbine of South Bangkok Combined Cycle Power Plant (SB-C10) manufactured by GE. There are 4 bearings which are comprised of bearing no. 1 and no. 2 supporting HP-LP Rotor as following figure and bearing no. 3 and no. 4 supporting generator rotor. The description of bearings manufactured by Kingsbury Inc. are shown in the table I.

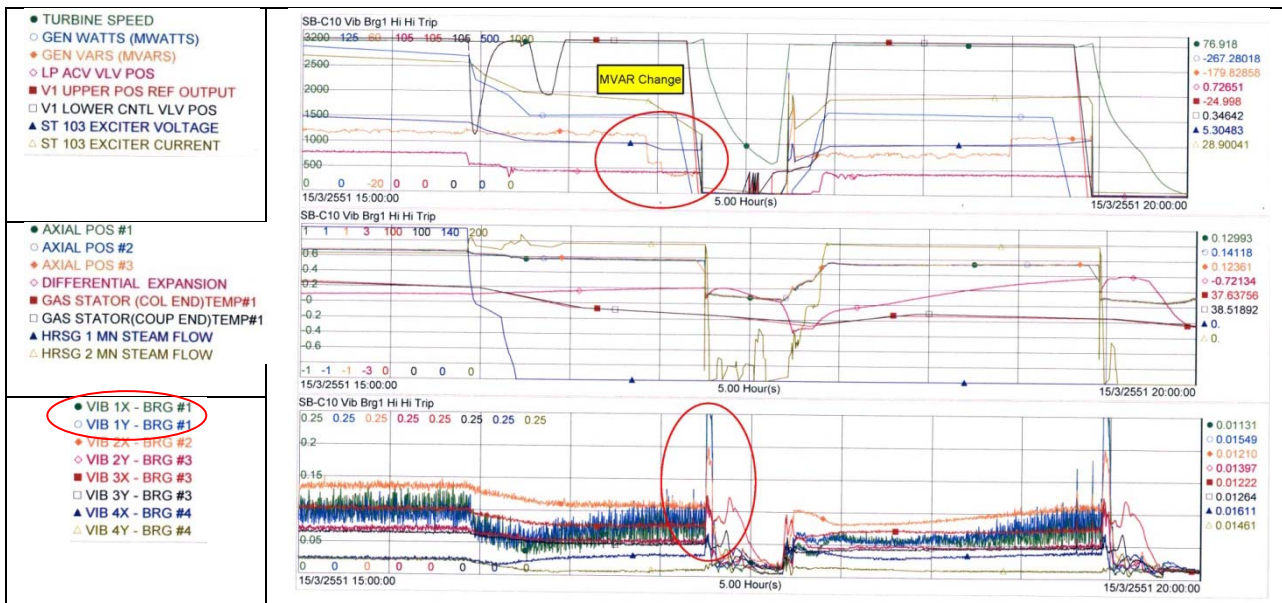
Figure 2 Vibration trend record of Trip event on March 15th, 2008

On March 15th, 2008, the vibration trend presented as the following figure was recorded the trip event without alarm signal observed by operator. This was shown the MVARs (GEN VARS) decreased from +10 to -10 when it was brought a Gas Turbine unit down. Then Steam Turbine was tripped by the vibration 1X=230 μm_{p-p} (2X=160 μm_{p-p}) within 20 minutes after. Moreover, the vibration at Bearing no.1 (VIB 1X, 1Y – BRG#1) was not consistency obviously. The Subsynchronous vibration could not be captured by Overall Vibration monitoring, so it was needed to measure the spectrum vibration.

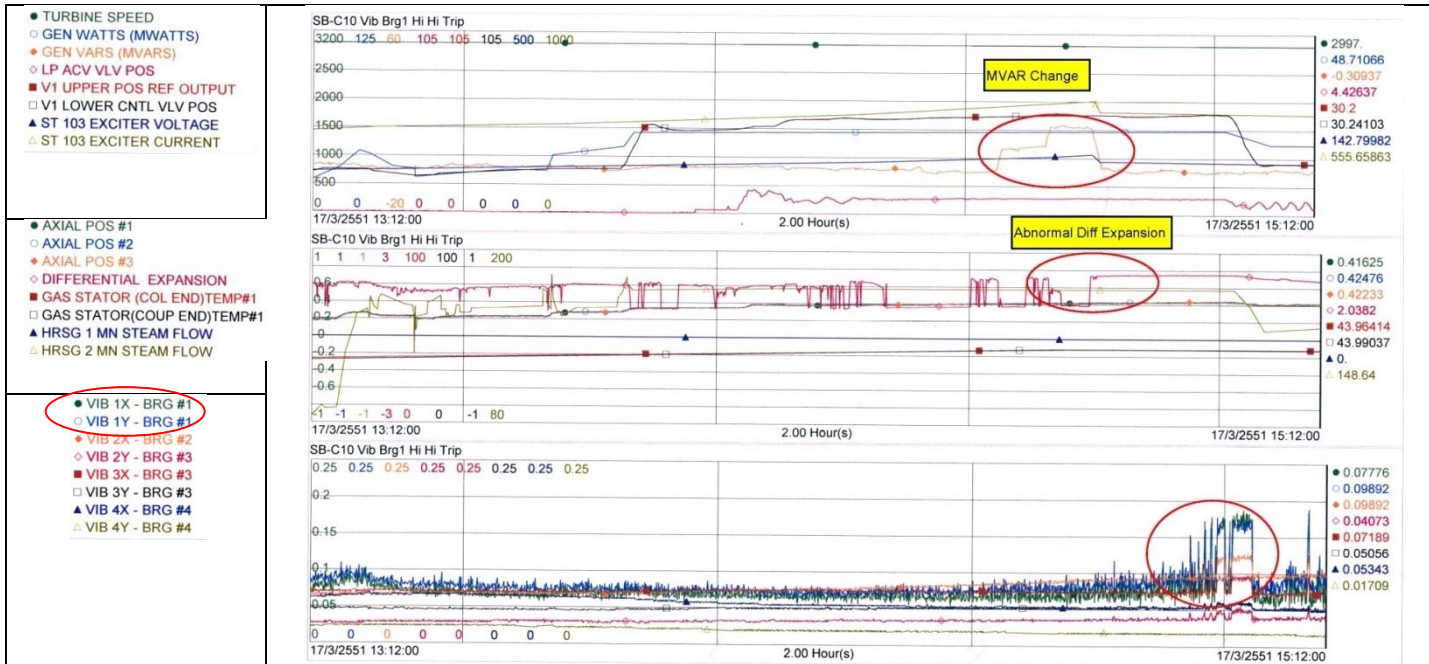
Figure 3 Vibration trend record of Trip event on March 17th, 2008

After the trip event with 230 μm_{p-p} , the vibration analyzing team had to record the Vibration Spectrum of minutes before trip again. During testing, it was found that the Steam Turbine suddenly had vibrated up to the overall magnitude of $1X=134 \mu\text{m}_{p-p}$, $1Y = 139 \mu\text{m}_{p-p}$ at 60 MW (52% load) when MVAR changed and abnormal differential expansion appeared as shown in the figure 3. As shown in figure 4, the Subsynchronous of 8-12 Hz captured had value up to 10 μm_{p-p} and then at the moment of trip event its value increased immediately up to 75 μm_{p-p} . Practically the normal Subsynchronous had valued not over 4-5 μm_{p-p} when a Steam Turbine is running. Therefore, this problem was implied that the possible causes could be fluid induced instability, the result of Bearing wear, Bearing over clearance, abnormal of Bearing Alignment.

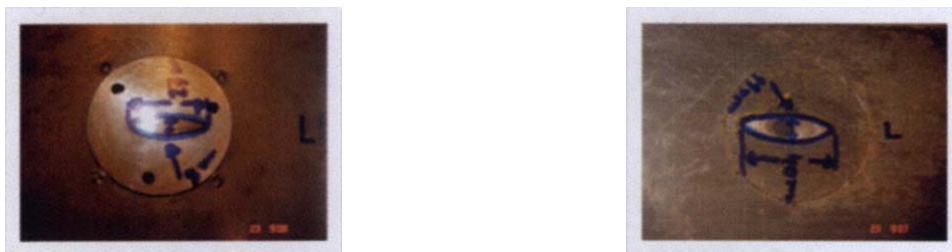
Figure 5 The pivoted shoe of Bearing no. 1 Condition

Then we had the meeting again and come up with Bearing Inspection for 8 days. After the Bearing no. 1 disassembly, the wear of pivoted shoe was shown in the figure 5, so the Bearing had to be replaced. As the following steps, Re-alignment (Turbine-Generator Coupling) had to be finished, as well as rubbing reducing by increasing oil seal clearance.

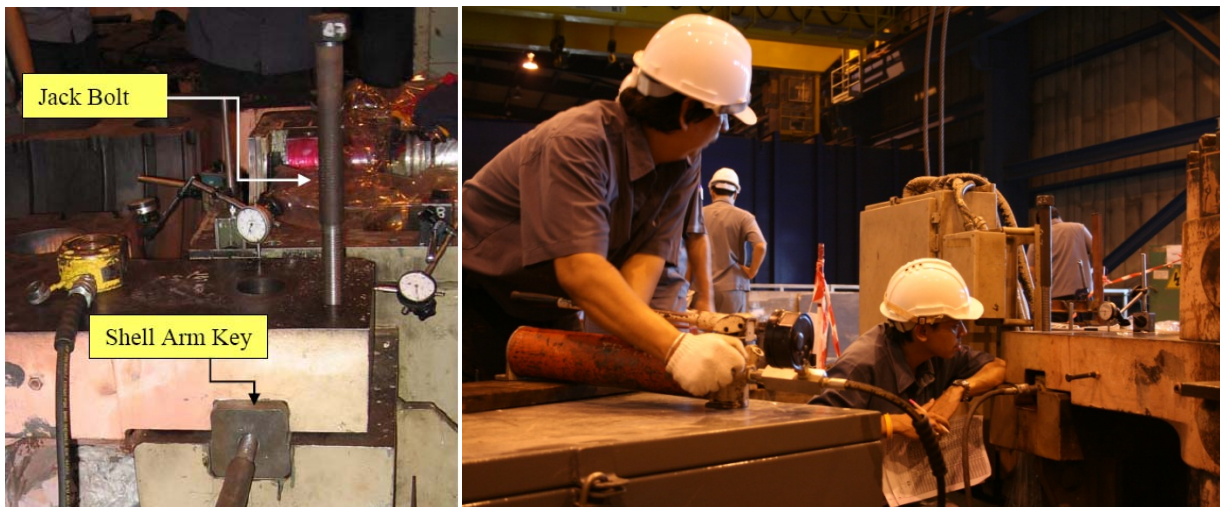
Figure 6 Hydraulic lifting the Front casing in the process of Horn drop test

After upper half casing removal, the former activities performed were dividing flange level inspection, front casing weight unbalancing test (horn drop test), and Bearing level compared with design level. The inspection was found that the Left-side of dividing flange level was lower than the right side of 3 mm., 69% of front casing weight unbalancing, and Bearing no.1 level is lower than design of 2.7 mils. Not only was the evidence found, the water induction trace also appeared. On June 3rd, 2008, the front casing weight unbalancing was adjusted to be within 10% as shown in figure 6, causing Turbine casing Lifting. So the following step was Internal Alignment, all diaphragm stage centering, and the latter activities are rubbing decreasing, re-alignment, expanding the anchor-bolt holes, Bearing inspection and setting. In spite of foundation deformation found, the corrective action could not be done because of time constraints. It has continuously monitored to protect the problem in time.

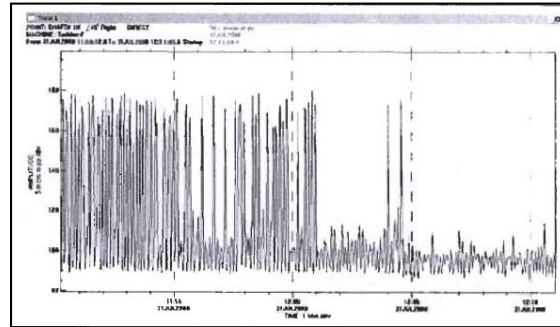
Figure 10 The Subsynchronous reducing from inlet Lube oil temperature Adjusting

Executing most of remedial action steps, we started up the unit again on July 20th, 2008. Notwithstanding Subsynchronous appearing of the 100 MW (87% load), the Turbine could bear on higher Subsynchronous magnitude of 80 $\mu\text{m}_{\text{p-p}}$ compared with 10 $\mu\text{m}_{\text{p-p}}$ of the previous trip event. In fact, the Steam Turbine condition was better, but it further needed fine tuning in the startup process by Compromised balancing to handle Turbine carefully. Because the Bearing no.1 is very sensitive, it can be stimulated natural frequency easily. Therefore suitable oil viscosity was adjusted by inlet Lubrication oil adjusting to help steadily rotatable bearings. The result was that the Subsynchronous magnitude reduced gradually. It was firstly decreased from 49°C to 46.5 °C, then the Subsynchronous was reduced as shown in figure 10. Next the temperature was reduced to 45°C, and the Subsynchronous was reduced dramatically. Finally, the unit could be brought back to dispatching control center to Thailand national electric grid on August 1st, 2008.
