REMEDIAL ACTION STEP OF SUBSYNCHRONOUS VIBRATION TRIP ON STEAM TURBINE

A CASE STUDY OF EGAT SOUTH BANGKOK POWER PLANT

18th Conference of the Electric Power Supply Industry (CEPSI)

By Parichart Suttiprasit

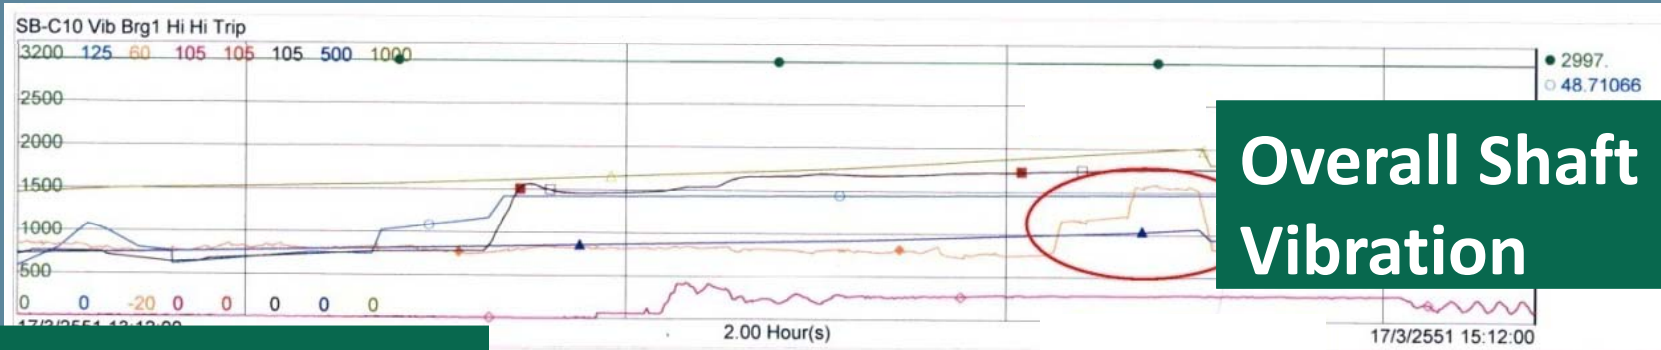
**Subsynchronous
from Spectrum
Vibration**

**8-12 Hz, 75 $\mu\text{m}_{\text{p-p}}$
During the event**

**10 $\mu\text{m}_{\text{p-p}}$
Before the event**

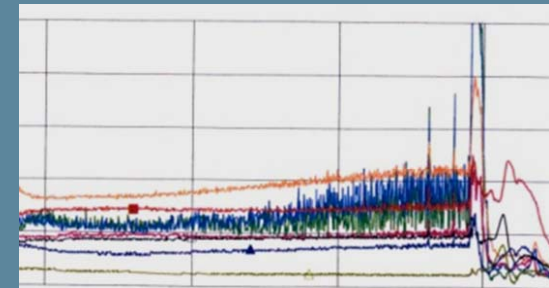
**Bearing
Inspection**

Bearing
Replacing

“Higher Load
Supply
Run Longer”

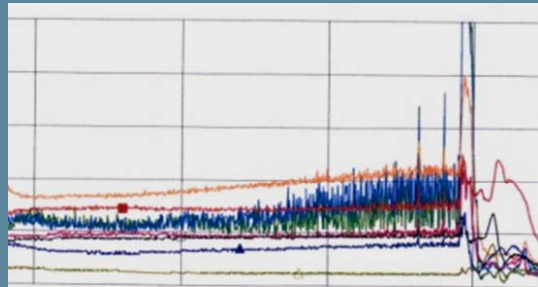
**Bearing
Inspection**

Although “Higher Load Supply
Run Longer”, it could not be reduced Vibration
without Internal Part Correction anymore!!!
