REMEDIAL ACTION STEP OF SUBSYNCHRONOUS VIBRATION TRIP ON STEAM TURBINE: A CASE STUDY OF EGAT SOUTH BANGKOK POWER PLANT

The 115 MW - single cylinder, single flow type - Steam Turbine of South Bangkok Combined Cycle Power Plant (SB-C10) manufactured by GE. There are 4 bearings which are comprised of bearing no. 1 and no. 2 supporting HP-LP Rotor as following figure and bearing no. 3 and no. 4 supporting generator rotor. The description of bearings manufactured by Kingsbury Inc. are shown in the table I.

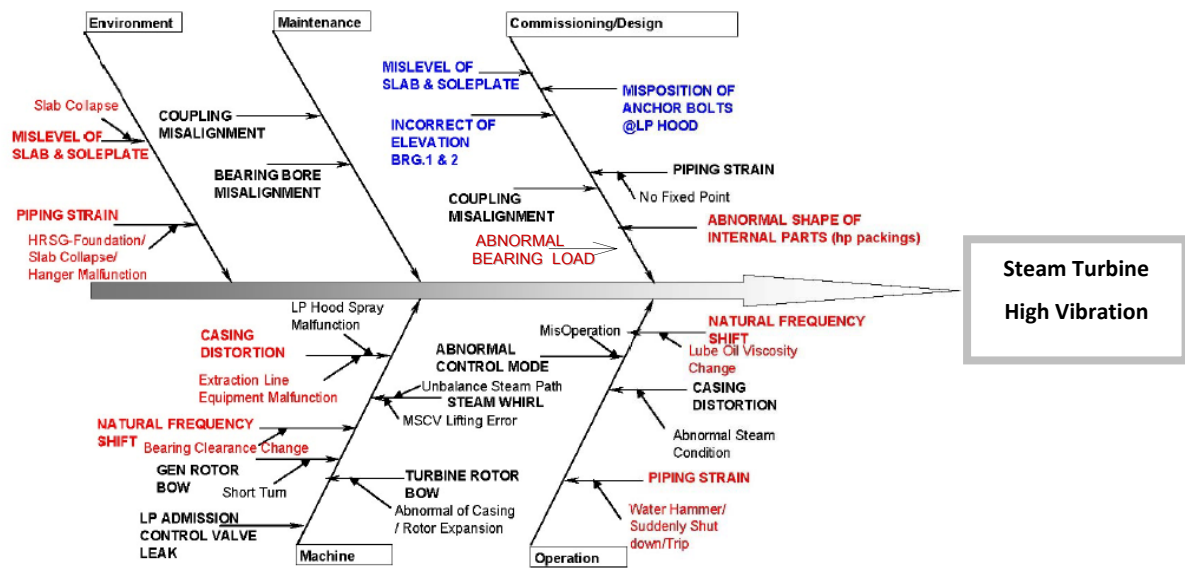
Figure 4 Root cause analysis diagram of Vibration high problem

The history record told us that the vibration high problem was found since 2002. It is highly vibrated at Bearing no.1 during 60 MW (52% Load) while another Gas Turbine started up and Steam was admitted; however, It could not be found any severe damage on any bearings. Therefore, we kept on correcting the problem by low speed balancing, field balancing, and bearing replacement depended on which obvious evidences found during such outages. Furthermore, the root cause analysis diagram in the below figure was the main tool to check the possible causes during problem solving.

In the initial countermeasure, there were 2 options, 6-day working on Compromised Balancing and 8-day for Bearing Inspection, in order to correct the problem. The 6-day working including Generator preparation on Compromised Balancing was selected. The Steam Turbine and Vibration team worked together to execute the three-run balancing and analyze the vibration vectors, but the vibration still high at $1x=200 \mu\text{m}_{p-p}$, instability of which had resulted by Subsynchronous as usual.

Then we had the meeting again and come up with Bearing Inspection for 8 days. After the Bearing no. 1 disassembly, the wear of pivoted shoe was shown in the figure 5, so the Bearing had to be replaced. As the following steps, Re-alignment (Turbine-Generator Coupling) had to be finished, as well as rubbing reducing by increasing oil seal clearance.
